Inspection Report Minerals Regulatory Program

Mine Name: ML 50053	Permit Numb	er: S/027/012	.3		
Operator Name: Ben Wilcken	Inspection Date: July 19, 2016				
Inspector(s): Peter Brinton	Time: mid-day				
Other Participants: none	Mine Status: Reclaimed				
Elements of Inspection	Evaluated	Comment	Enforcement		
 Permits, Revisions, Transfer, Bonds Public Safety (shafts, adits, trash, signs, highwalls) Protection of Drainages / Erosion Control Deleterious Material Roads (maintenance, surfacing, dust control, safety) Backfilling/Grading (trenches, pits, roads, highwalls, shafts, drill holes) Soils Revegetation Other 					
Permit fee: Bond Renewal Date: Bond Amount:

Inspection Purpose: Evaluate reclamation for a possible partial bond release

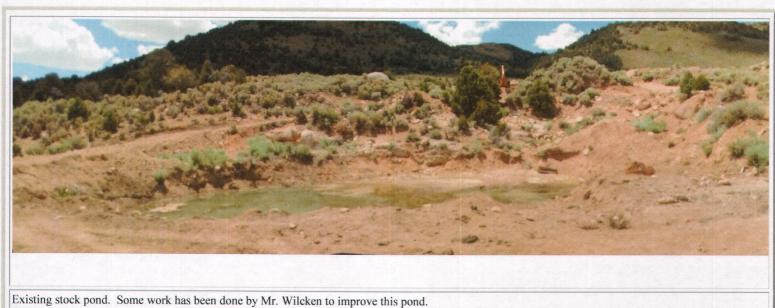
Inspection Summary: Regrading associated with this permit was satisfactorily completed, with the exception a small hole (up to 8 feet deep) at the current backhoe location (upstream of the stock pond). Also, one disturbance area is becoming a road that parallels the original road, with an island of sagebrush in between them. The hole must be backfilled, and the new path access removed using a berm of rock and/or downed trees or heavy vegetation. A few pieces of trash remain, and need to be removed. Mr. Wilcken left his trackhoe onsite so that I could notify him of any additional requirements, of which I have notified him by phone. Other small and active mining areas (mostly downstream) are not associated with this permit, and do not require a permit, unless excavation equipment is used.

Operations area during active operations.

Operations area after regrading. Note the hole below the backhoe and wood.

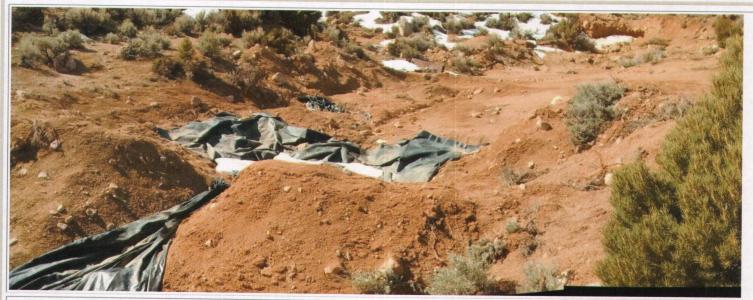
Upper pond during active operations.

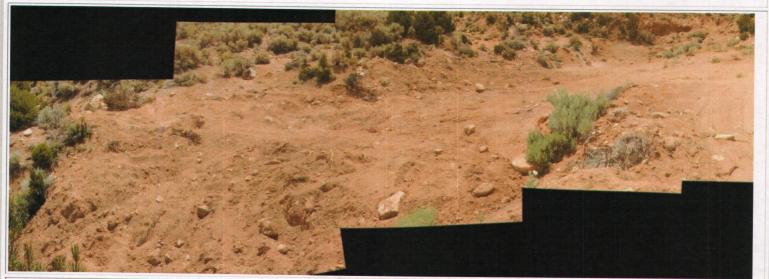
Upper pond after regrading.

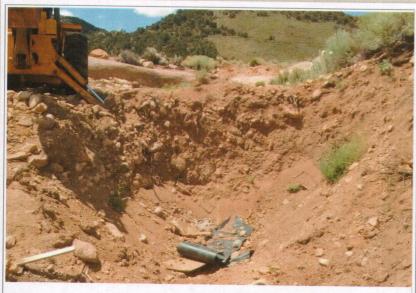
Remaining pit to backfill before regrading will be complete.

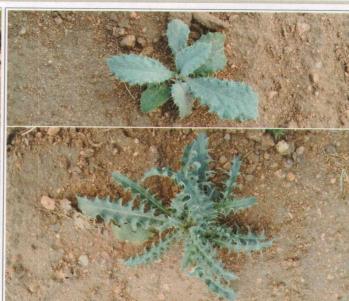
Beneficial volunteer and weedy vegetation was starting to grow, including a few thistle rosettes which I removed, since their species was unclear. Cheatgrass is present in surrounding areas. Given the relatively good precipitation at this elevation (~7800 ft), cheatgrass shouldn't dominate if the site is appropriately seeded and roughened this fall. Photos were taken to document site conditions.

Two of a handful of thistle rosettes observed and removed.

Considering the regrading and clean-up work done to date, it is recommended that a partial release of reclamation surety be granted, with adequate revegetation bond retained. Soil roughening and seeding should occur this fall.

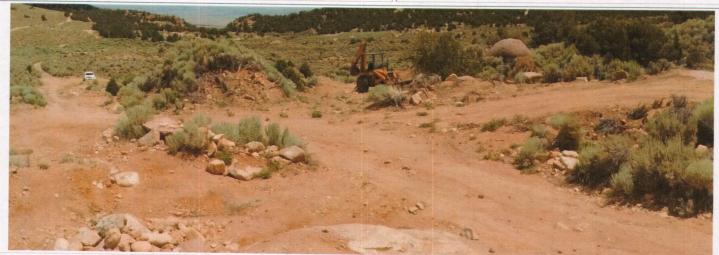
Two roads, one of which still needs to be bermed.
